The Witchert Buildings of Buckinghamshire, England: Learning Sustainable Construction from our Ancestors

Dr. Richard Burt

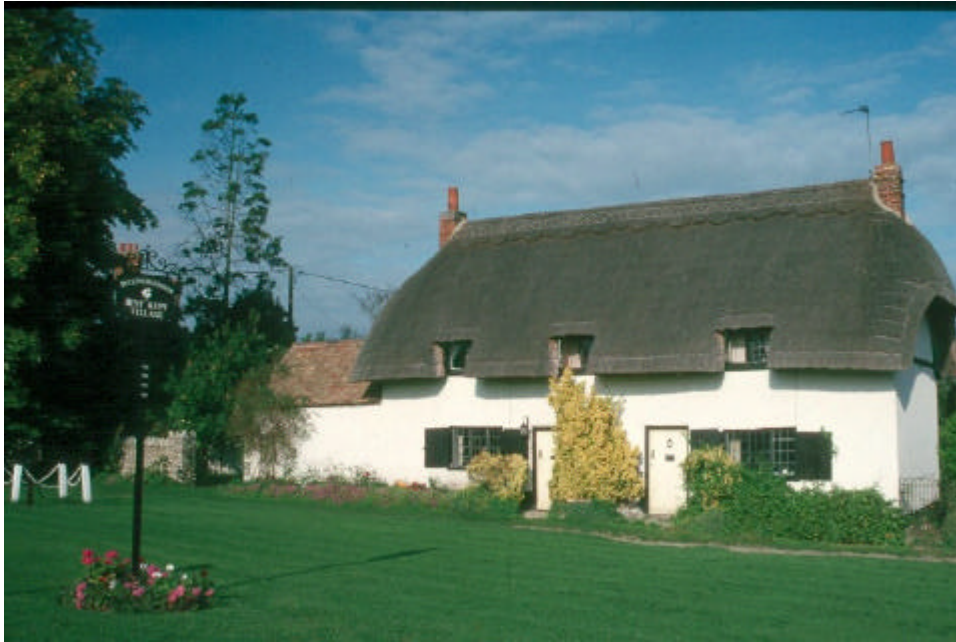
Figure 1 A pair of witchert cottages Cuddington, Buckinghamshire.

The word “witchert”, “wichert”, “whitchert” or “wychert” is used in Buckinghamshire, England to describe a particular type of sub-soil, from which boundary walls, houses, churches and barns have been constructed. The term witchert is thought to be a local corruption of the words “white earth” which describes the creamy-beige color of the soil that is used to build the structures (Andrew, 1986). Witchert construction is one of several earth-building techniques that have been used in England in the past, such as Cob and Clay Lump. The exact number of witchert buildings in Buckinghamshire is unknown, but a search of English Heritage’s database of listed buildings found over 200 listed witchert structures in Buckinghamshire. Listing by English Heritage gives statutory protection that limits the amount of alteration and addition that can be carried out on the structure. The structures are located in a number of small villages located to the south-west and north-west of the county town of Aylesbury. The majority of structures are in the village of Haddenham and the adjoining villages of Cuddington, Chearsley and Long Crendon. The majority of these protected structures range from the 17th, 18th & 19th Centuries, and their continued existence can be contributed to the understanding of the original builders on the strengths and weaknesses of earth as a building material. Pair of typical witchert cottages is shown in figure 1.

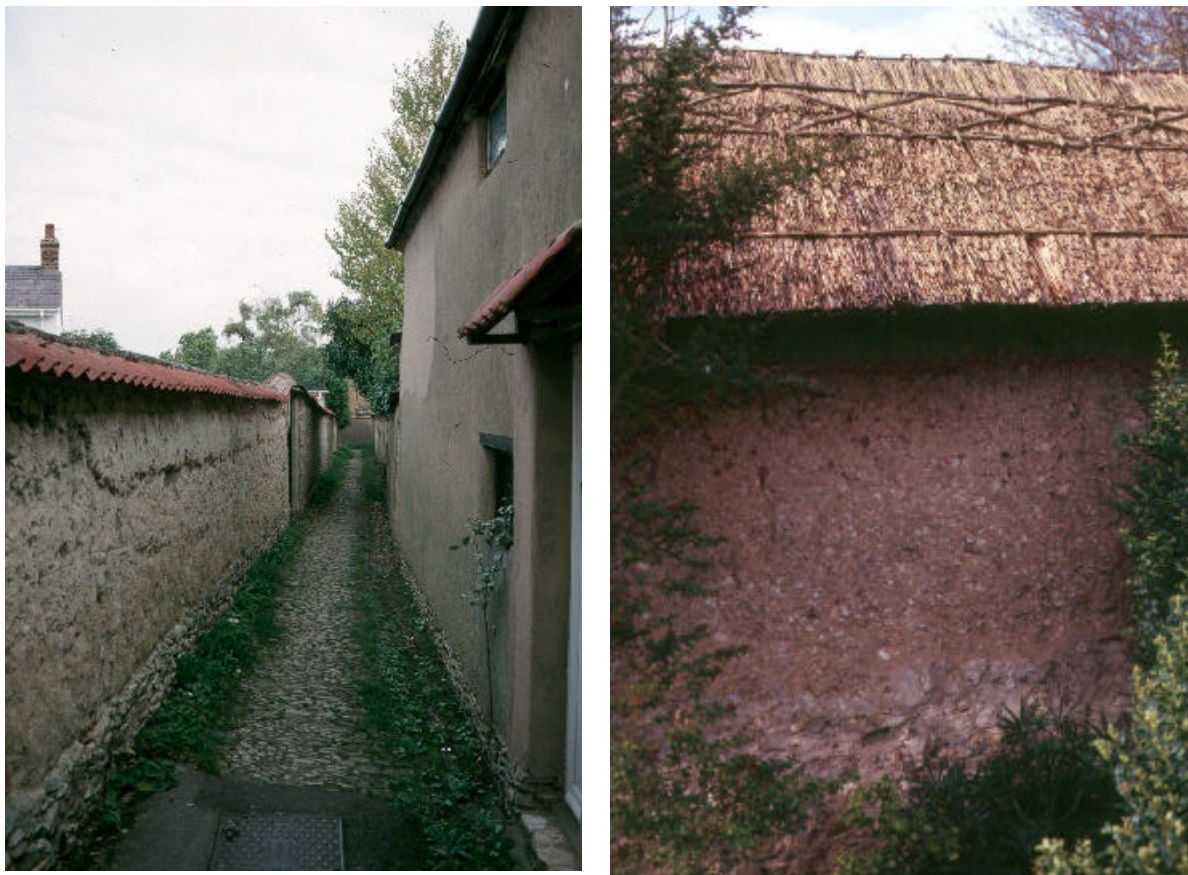
Figure 2 Witchert walls showing tiled and thatched copings.

In Haddenham and the surrounding villages there are a number of different structures. The majority of the structures are dwellings, but there are also a number of barns, stables and a handful of chapels. What are most interesting are the boundary walls that appear around and within the village of Haddenham. These walls, some as high as nine feet (Andrew, 1986) were often topped with thatched, although most of the surviving examples have tiled copings. Figure 2 shows a tiled coping and a thatched wall.

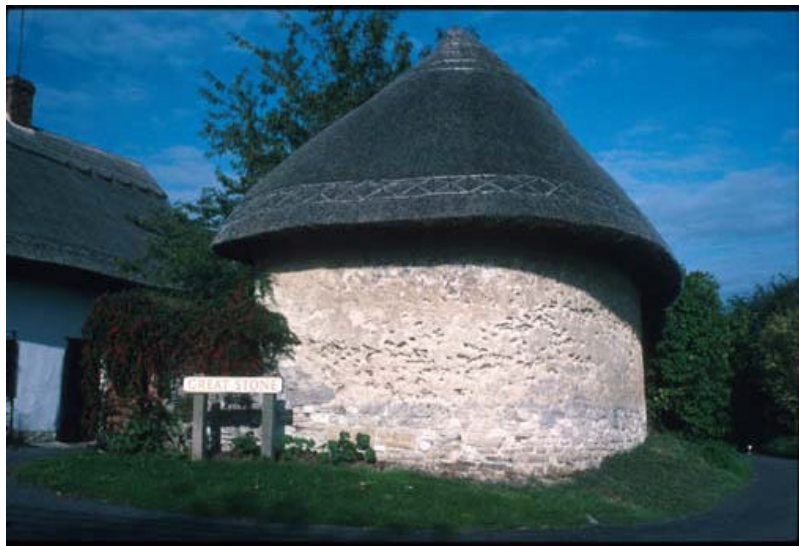
Figure 3 Witchert Stable in Cuddington, Buckinghamshire.

The witchert builders understood their material well. They knew its strengths and weaknesses and constructed accordingly. There is a saying that appears regularly in the literature on earth building that says, “*Give a building a good hat and a good pair of boots and it will last forever*”. The witchert builders heeded this advice well. Figure 3 shows a grade 2 listed stable building. The listing is as follows:

Stable building and store. C18. Witchert on a rubblestone plinth. Hipped thatch roof. 2 bays with gable end to road and east wall along Spicketts Lane, the witchert wall rounded at the junction. West elevation facing Nunhayes Cottage has central board door and windows either side (English Heritage, 2002).

This building shows clearly how the builders understood the limitations of the material. The building has a substantial footing that extends well above the ground; these are the buildings “boots.” This prevents the earth material from becoming excessively wet from either ground water or by splashing rainwater. Water is the main cause of deterioration of earth buildings. The changes in volume that the addition and removal of water causes, severely weakens the earth causing it to break away. The thatched roof provides the buildings “hat”. The substantial overhang of the roof keeps the wall dry by protecting it from the rain. Many of the witchert walls are left unfinished, as the original builders knew that if they were constructed wisely no additional protection was required. The deterioration that can be seen in figure 3 was caused not by water but by the activities of Masonry Bees who have nested in the walls. Insects and rodents make no distinction between earth in the ground or in walls, and their activities have caused considerable damage to many buildings in the area.

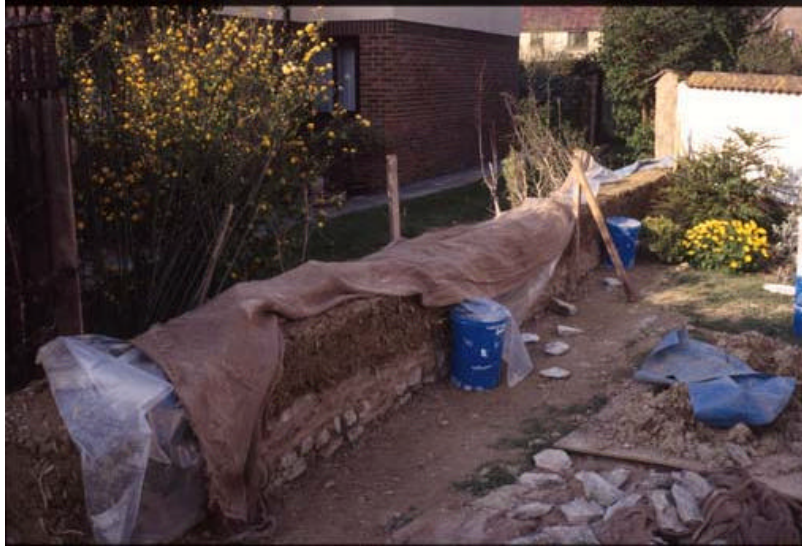
Figure 4 Reconstruction of a witchert wall in 1995.

rebuild a short length of boundary wall in the mid 1990's they were unable to find any local contractors with the requisite expertise. A specialist building conservation contractor was finally hired from outside the area to reconstruct the wall. Figure 4 shows the wall during its reconstruction.

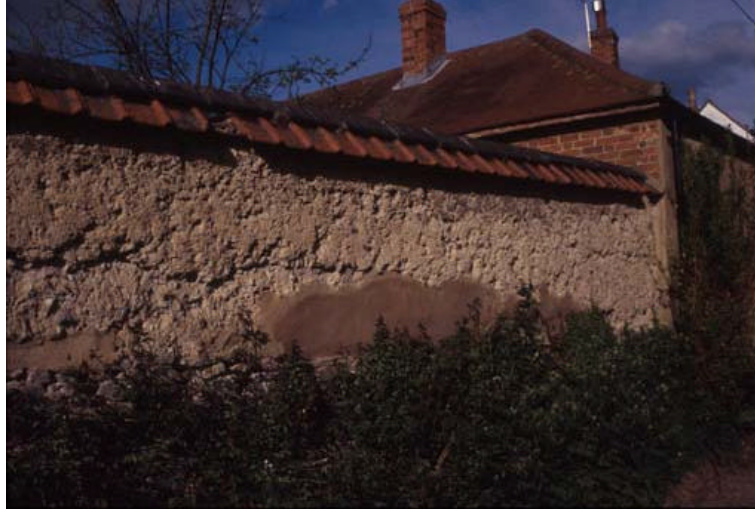
Figure 5 Repairs to a witchert wall using interior plaster.

This loss of knowledge has also led to poor maintenance and repair of some of the buildings. When the author inspected a number of the boundary walls in 1996 he identified a number of poor repairs to the walls. These included the use of heavy concrete renders to walls that in some places had cracked and allowed water to penetrate and damage the witchert. The wall in figure 5 shows where an area of eroded wall had been repaired using interior plaster that is not only unsightly but will deteriorate rapidly when exposed to rain.
